Manhole Inspection Summary

Manhole # S33A__011MH

Location Address: **WALTERS ART GALLERY (ALLEY)** Cross Street: **WASHINGTON PL**

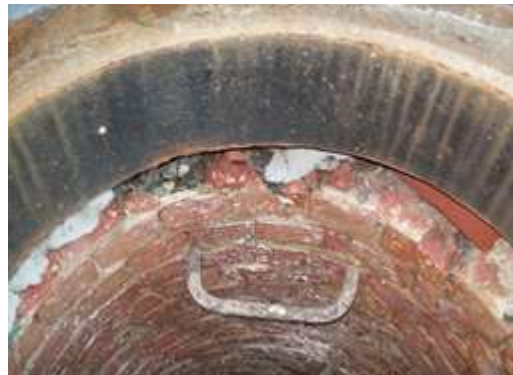
Defect 2

Condition: ☐ Sound ☐ Cracked ☐ Root Intrusion ☒ **Loose Brick** ☒ **Deteriorated**

LOOSE BRICKS AND DETERIORATED CHIMNEY

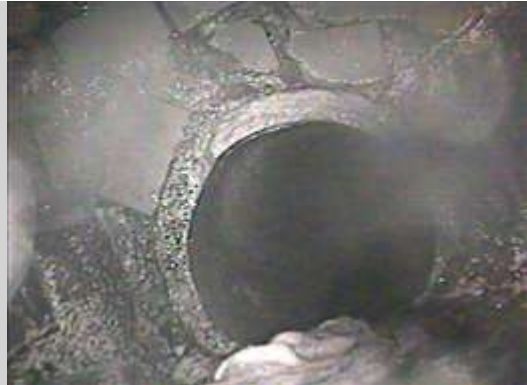
12 O'Clock Outflow

8 in. Circular Gravity Sewer
Pipe Out @ 12 O'Clock

Infiltration: **None** Pipe Seal Cond: **Sound**

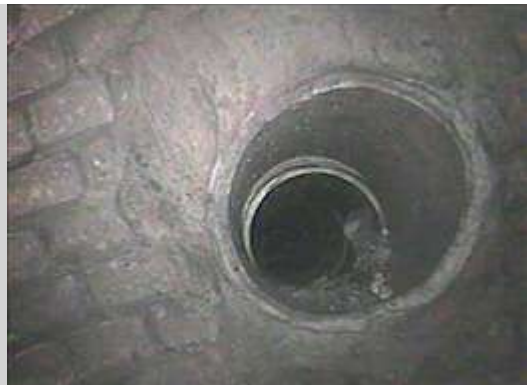
2 O'Clock Inflow

8 in. Circular Gravity Sewer
Pipe In @ 2 O'Clock

Infiltration: **None** Pipe Seal Cond: **Sound**

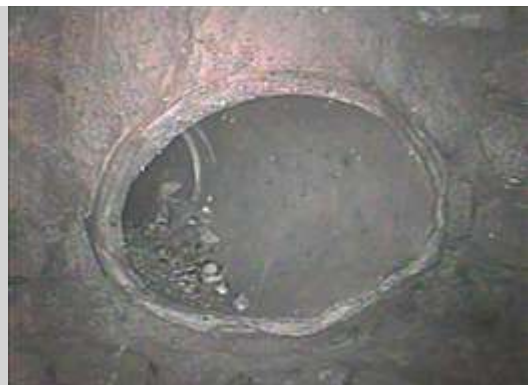
6 O'Clock Inflow

Pipe In @ 6 O'Clock

Infiltration: **None** Pipe Seal Cond: **Sound**

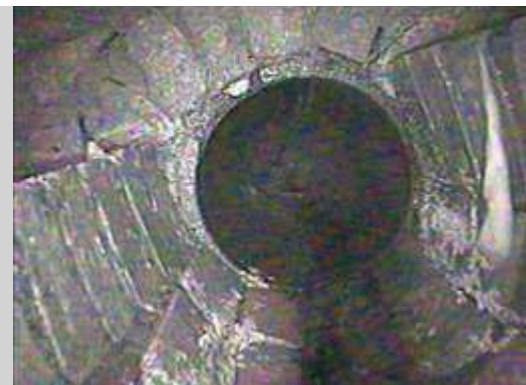
Drop In @ 6 O'Clock

Drop: **Inside** **Direct**

Drop Condition: **Partly Clogged**
